NASA/TM—2005—212559

Debris/Ice/TPS Assessment and Integrated Photographic Analysis of Shuttle Mission STS-111

Author Name: Armando Oliu

June 2005

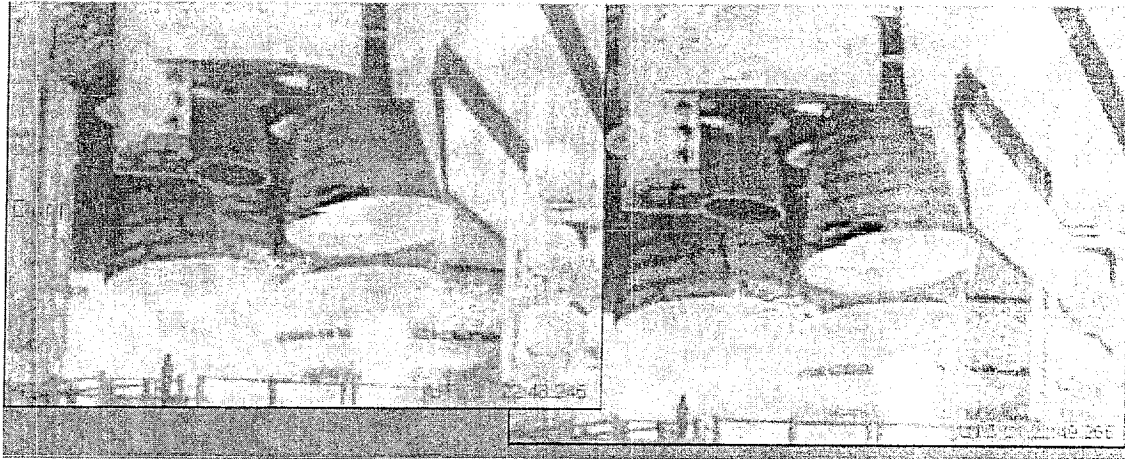
Figure 2.1 (B) Light Colored Area on Inside of SSME #1 (Camera E77)

A light colored area was seen on the inside of SSME #1 that may have been an indication of a hot wall leak. However, KSC reported that the view was showing a small area of turbulence inside the SSME #1 engine that was caused by weld beads.

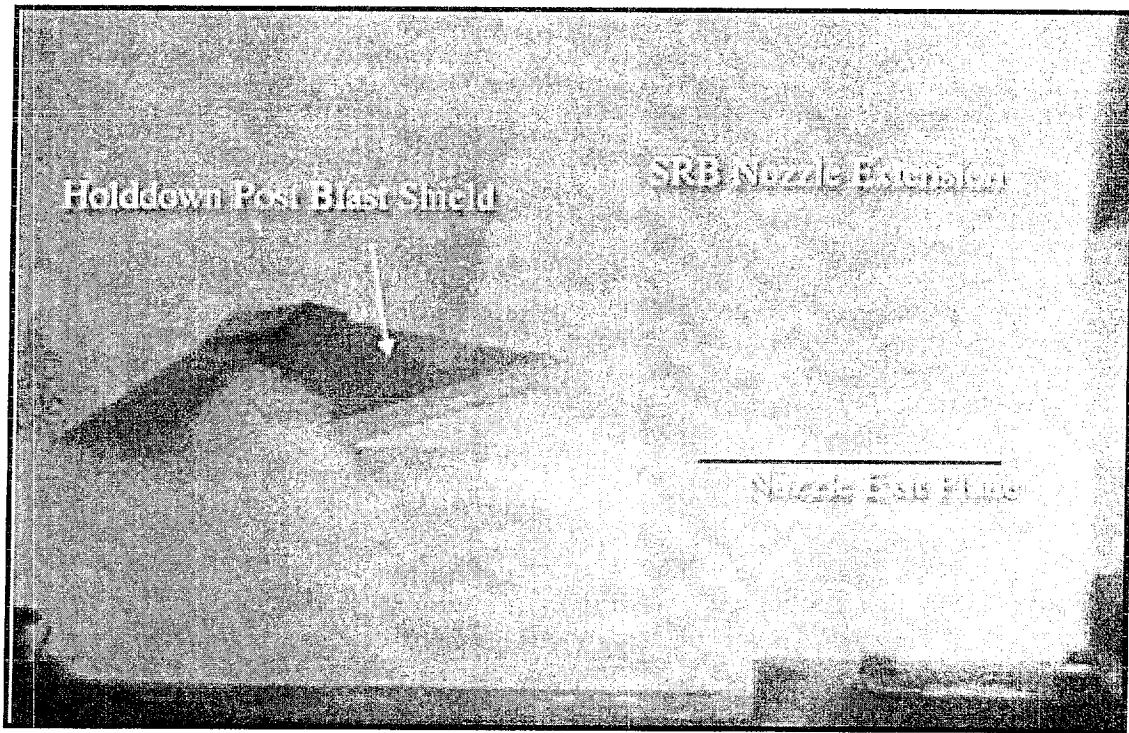
Figure 2.1 (C) Holddown Post Blast Shield Closes Late (Camera E10). Image Courtesy of Marshall Space Flight Center.

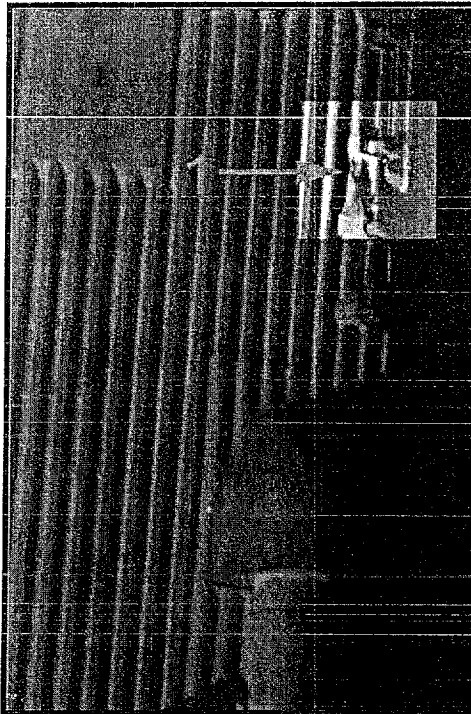
One small erosion mark was noted on an intertank stringer head near the forward end of the LO2 feedline in the -Y direction from the LO2 feedline bellows.

Figure 2.3.1 (B) 35mm Image of TPS Erosion on the ET Intertank (Frame 39)

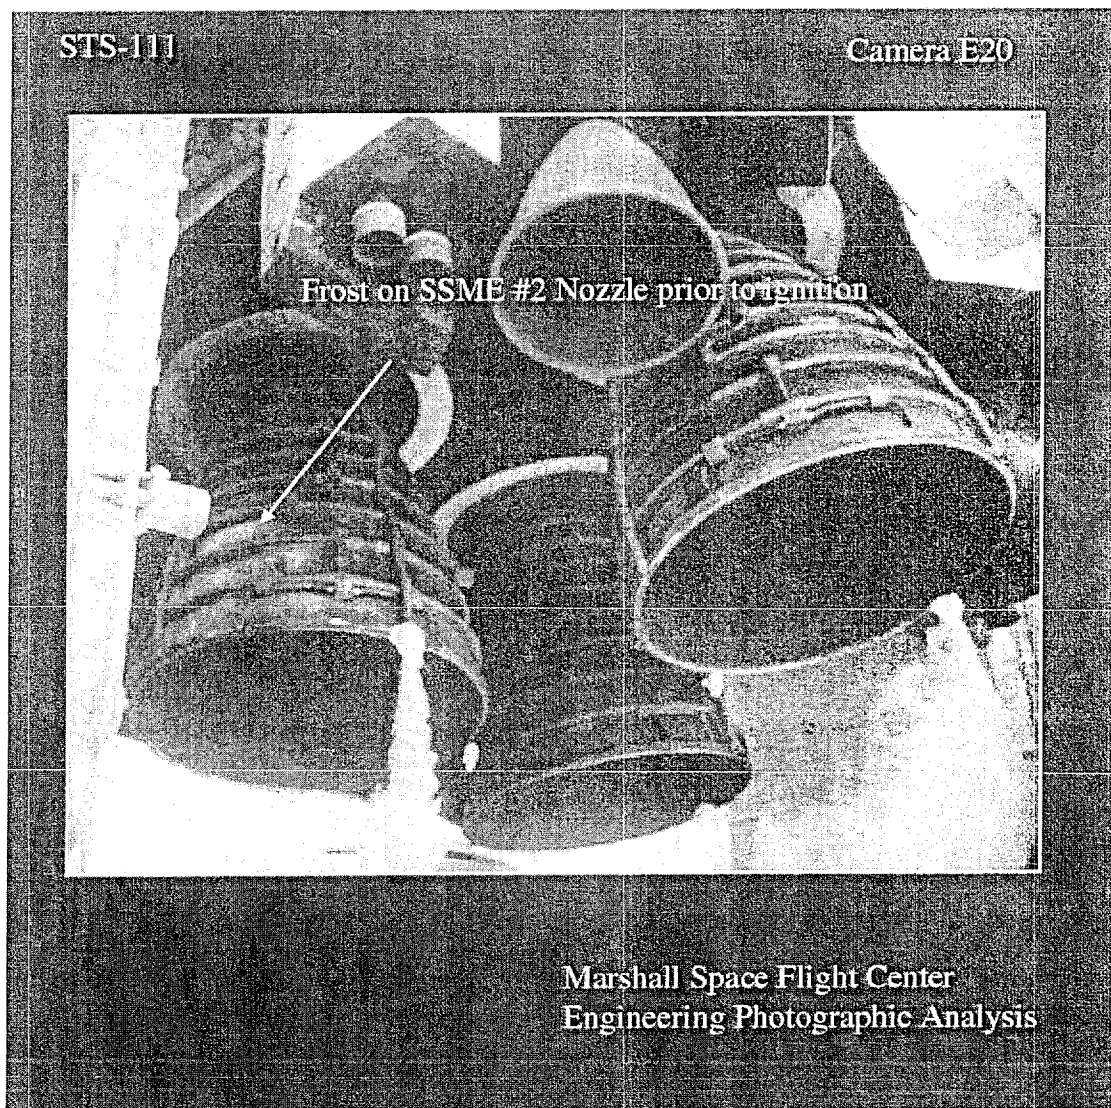
Frost was observed on SSME#2 Nozzle prior to SSME ignition.

Figure 11. E20: Frost on SSME#2 Nozzle Prior to Ignition

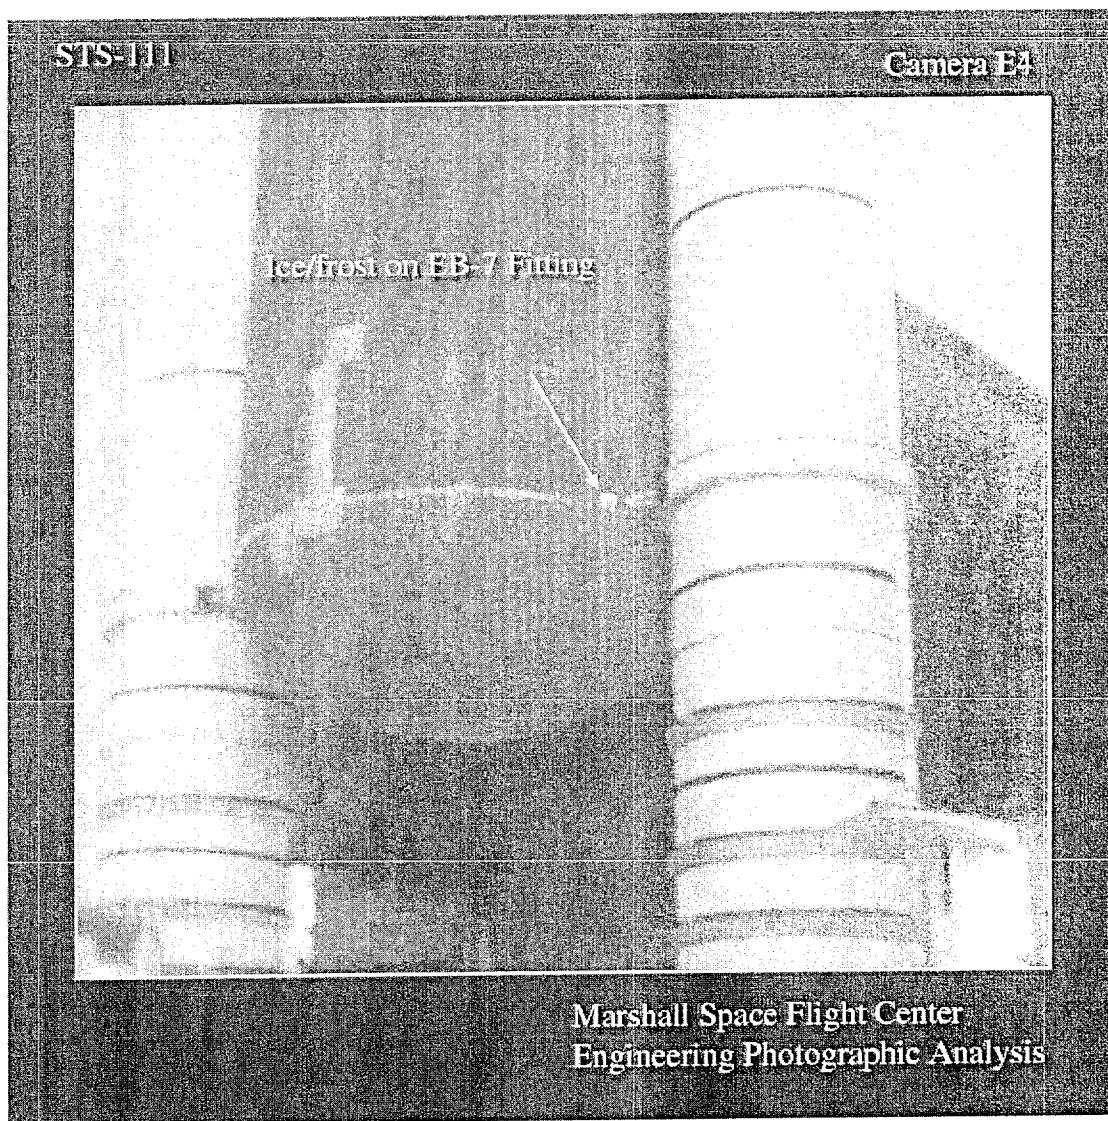
A light-colored area, indicative of ice or frost, at the EB-7 ET/SRB Aft Attach location was observed prior to liftoff.

Figure 14. E4: Ice/Frost on ET/SRB Aft Attach

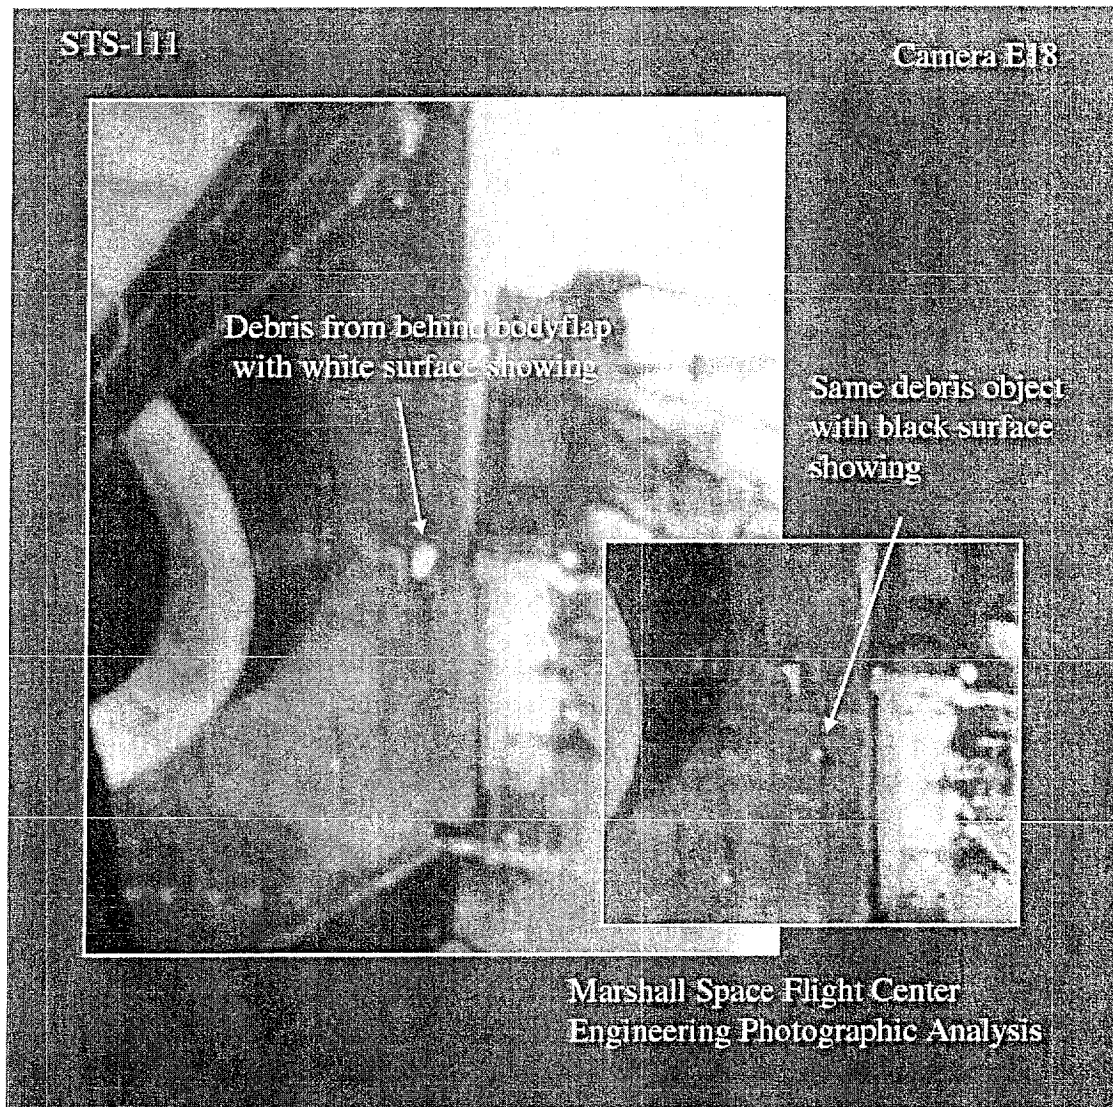
A debris object was observed forward of the +Y side of SSME#3 nozzle. The debris object was light colored on one side and dark colored on the opposing side, indicative of a chipped Orbiter tile. The images below were obtained between 156:21:22:46.155 and 156:21:22:46.218 UTC.

Figure 16. E18: Debris with White and Black Surface

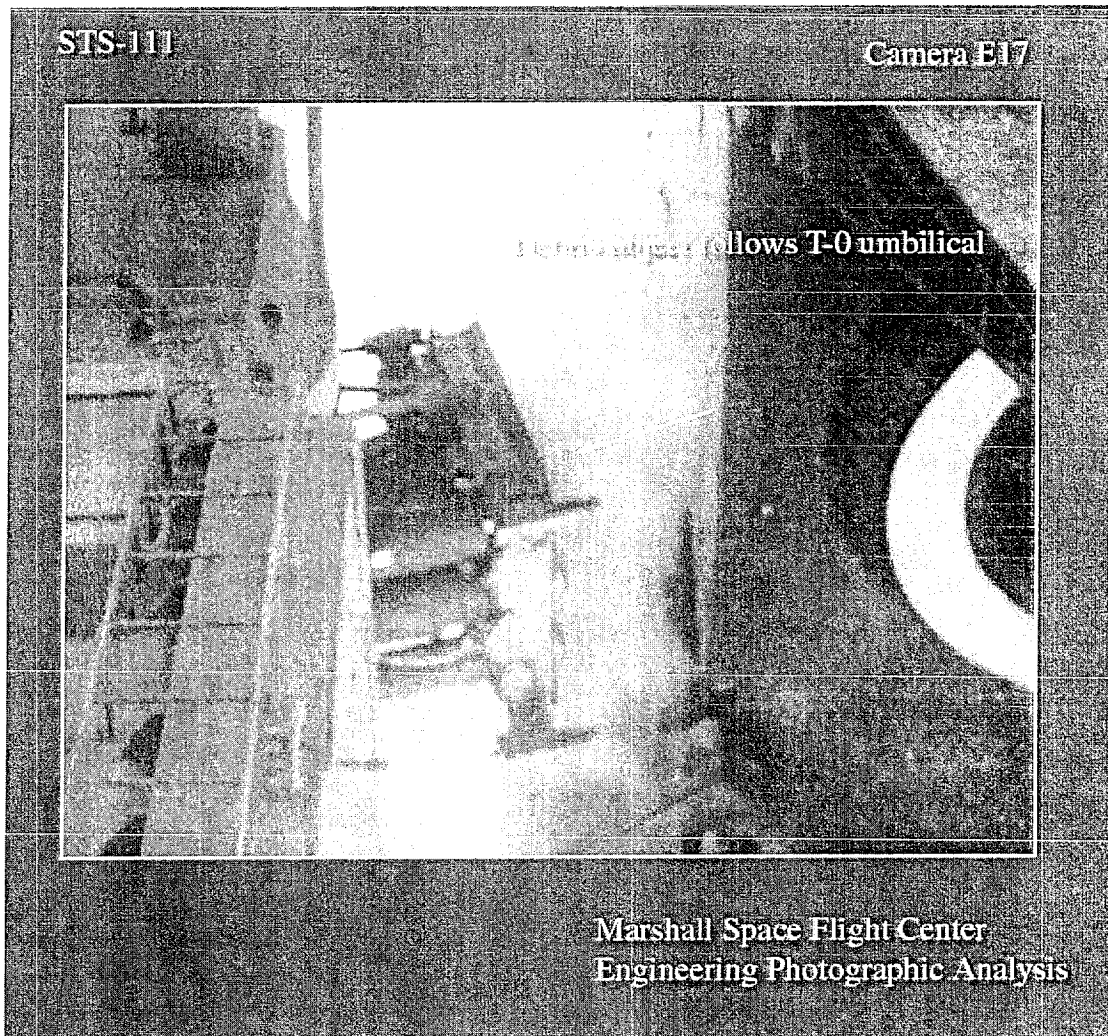
A dark object follows the T-0 umbilical toward LO2 Tail Service Mast during umbilical retraction. The object appears connected by wire to the umbilical assembly, but vapors surrounding the object make positive identification of an attached wire difficult. The image below was timed at 156:21:22:49.499 UTC.

Figure 17. E17: T-0 Umbilical Object

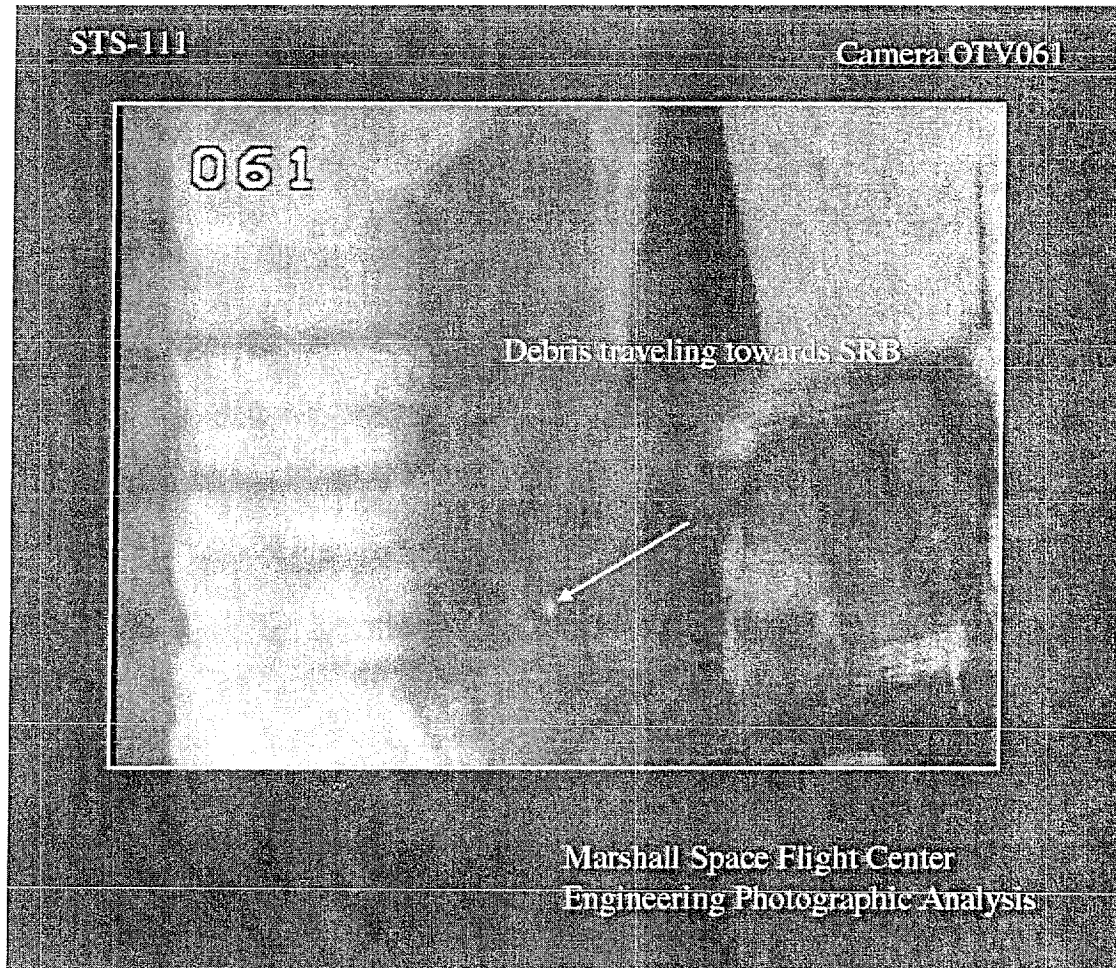
A light-colored debris object was observed traveling toward the LSRB just after liftoff.

Figure 19. OTV061: Debris Traveling Toward SRB

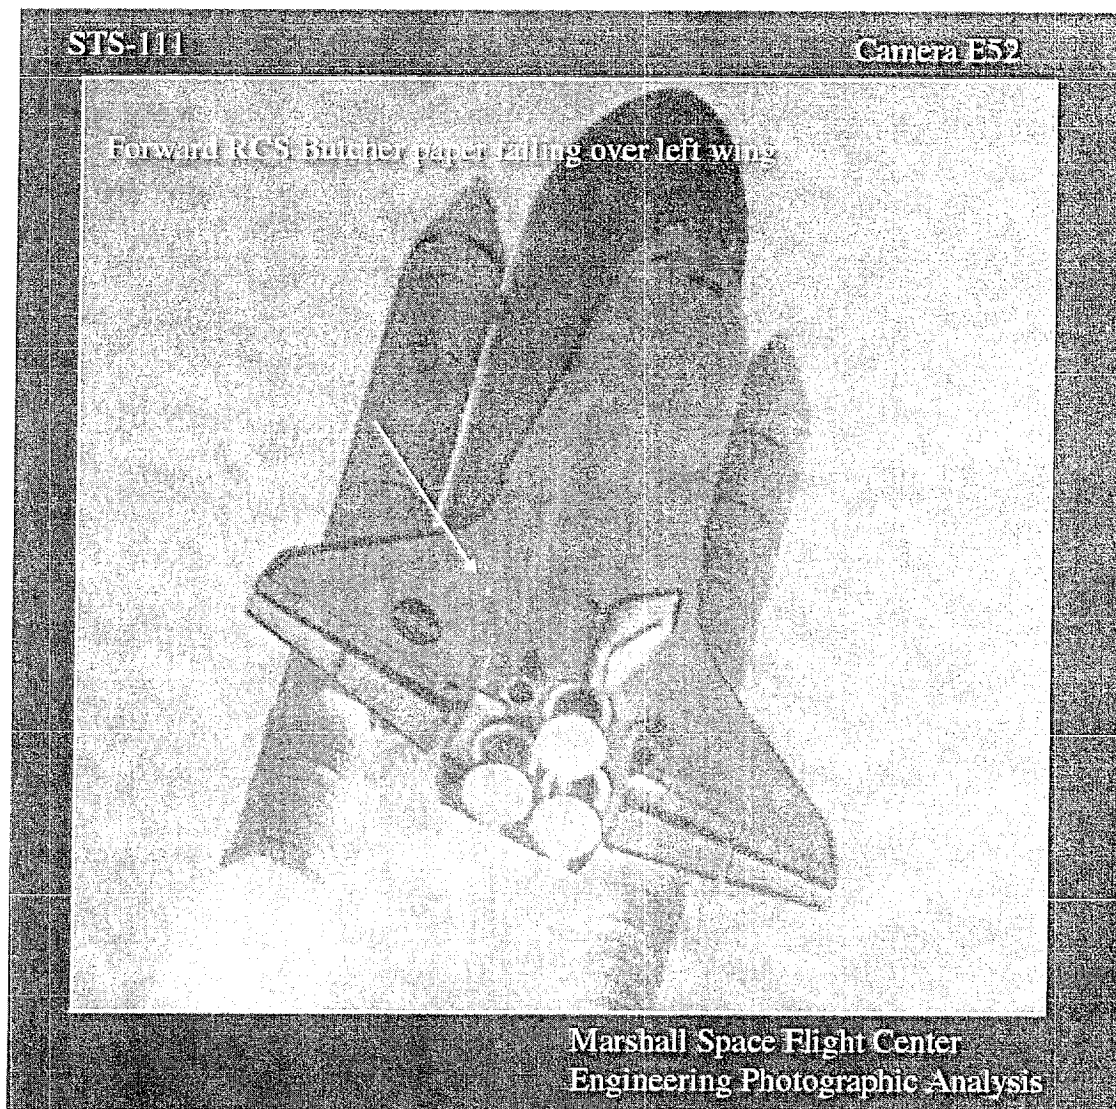
Forward RCS Butcher Paper was observed falling over the left wing of the Orbiter during ascent.

Figure 22. E52: Forward RCS Paper Falling Aft

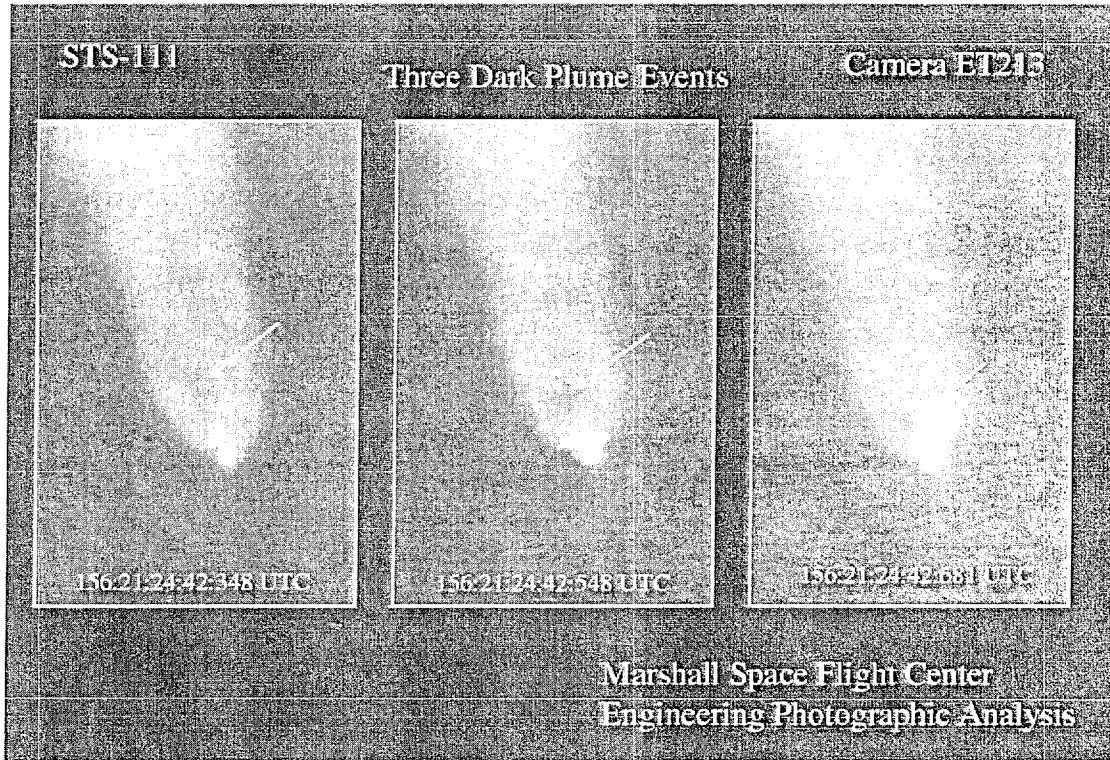
Three separate events in which dark areas appeared in the SRB plumes were observed. The events were timed at 156:21:24:42.348, 156:21:24:42.548, and 156:21:24:42.681 UTC.

Figure 31. ET213: Dark Plume Events

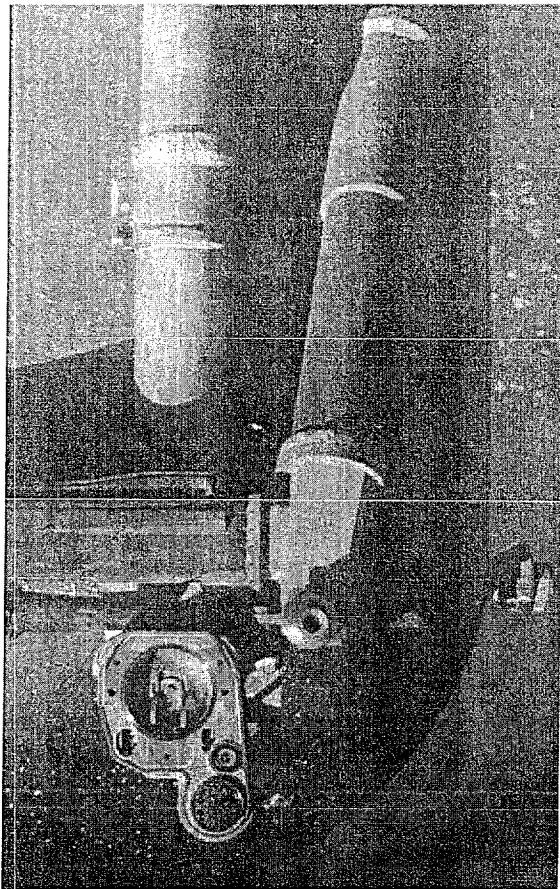
Figure 38. UMB35mm: Frame 12

TPS loss was typical. Normal popcorning and divoting of the aft dome, Figure 38. Typical TPS missing from thrust strut and LO2 feedline, Figure 38 and Figure 39. Divot noted on thrust strut, Figure 38. Three small divots noted, two under and one on the +Y side, near the bipod, Figure 41. One divot on intertank noted near forward -Y side of the LO2 feedline, Figure 43. Nosecap appeared nominal, Figure 44. The purge seal was noted in place around the EO3 joint, Figure 38. Glare from within EO3 joint bore observed, probably a reflection from the chamfer of EO3 bolt, Figure 38. A small positive yaw angle noted as ET moves away from Orbiter is noticeable through the sequence of frames.
